Technical Note N-1072

SEAL SYSTEMS IN HYDROSPACE, PHASE III:

EFFECTS OF LONG TERM HYDROSPACE EXPOSURE

ON SEAL SYSTEM INTEGRITY. 189 DAYS AT

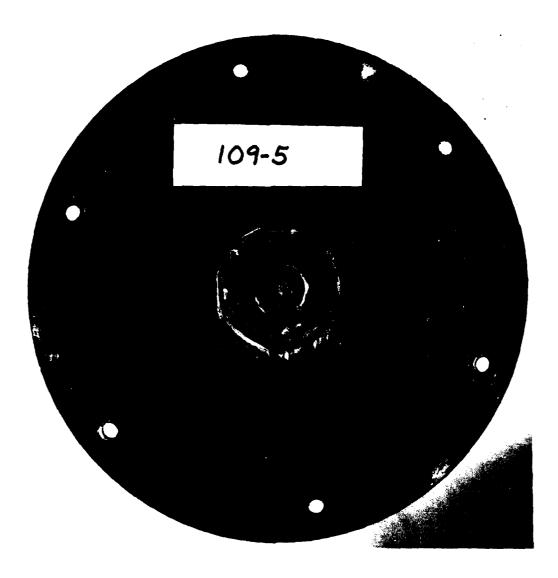
Visual observation of the outside of the seal test jigs after recovery as given in table 3, showed the efficacy of zinc anodes in reducing the external corrosion of the carbon steel and aluminum test jigs as shown in Figures 19-22. Without anodes the carbon steel test jigs were covered by thick, flaky, loose red rust. With anodes the exteriors of the carbon steel test jigs were relatively clean after recovery, but quickly formed a thin layer of adherent red rust thereafter. The anodes on the carbon steel test jigs showed scattered areas of white corrosion products. The effect of anodes on the external corrosion of carbon steel test jigs with internal corrosion resistant metal overlays was the same as for the carbon steel seal test jigs without internal corrosion resistant metal overlays. The aluminum seal test jigs without anodes were covered with spots of white corrosion products which were found to cover pits up to 28 mils deep.

Figure 20. Carbon steel seal test jig with anode after recovery.

Showing thin rust on the seal jig and white corrosion products on the anode.

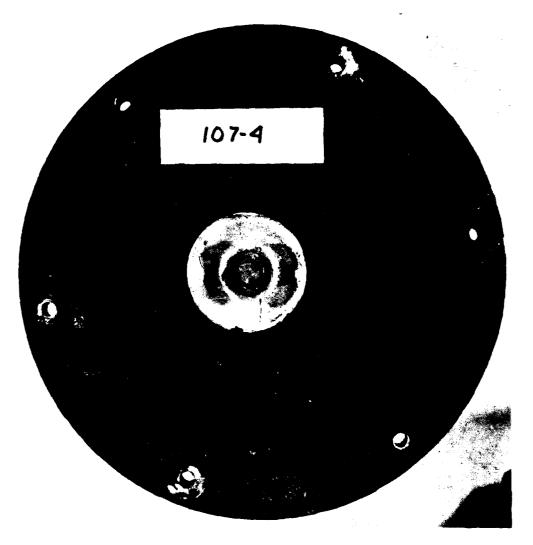
The anodes on the aluminum test jigs were covered with a thick layer of white corrosion products. As shown in Table 4, weight losses of the zinc anodes showed no significant difference between any of the test jigs constructed from carbon steel regardless of configuration of seal or flange. The anodes from the carbon steel test jigs with corrosion resistant metal overlays showed a higher weight loss than the carbon steel test jigs without overlays. The anodes from the aluminum alloy test jigs showed a low loss of weight compared to that of the anodes from the carbon steel test jigs.

Figure 22. View of top of aluminum seal test jig with anode after recovery showing thick white corrosion products on the anode.
